Confidential Inspection Report

Inspection Date:
11-12-2012.

Inspection Site:
25 Oak Street, Cincinnati,
OH 45233.

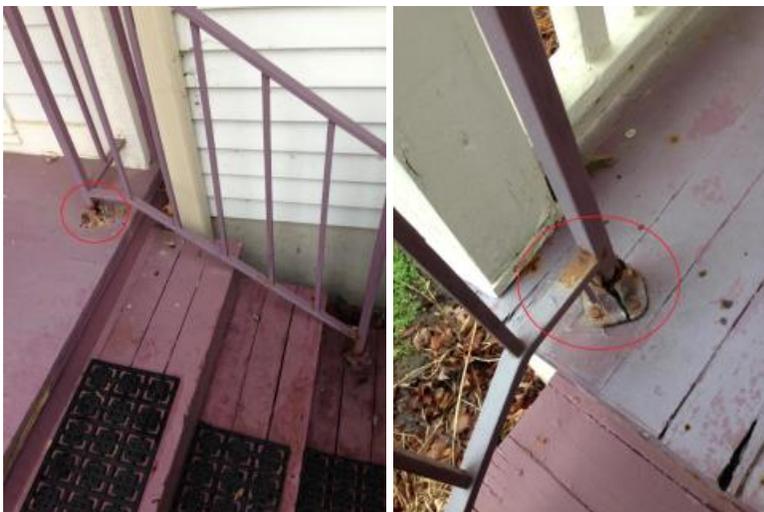
<i>Condition:</i>	<input type="checkbox"/>	<input type="checkbox"/>	<input checked="" type="checkbox"/>	The handrails on the right and left porches were loose. This is a safety hazard. Repairs should be made by a qualified contractor.
-------------------	--------------------------	--------------------------	-------------------------------------	--

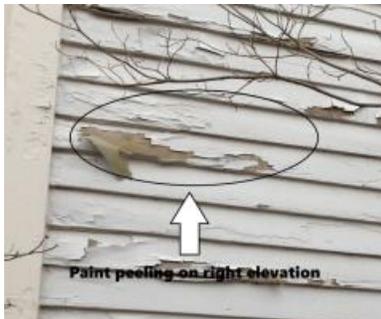
The Exterior Wall Cladding (wood lap siding) needs to be painted by a qualified contractor. The paint is peeling which can allow the wood to deteriorate if not corrected.

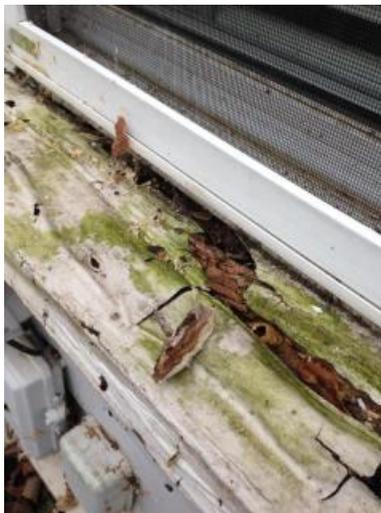
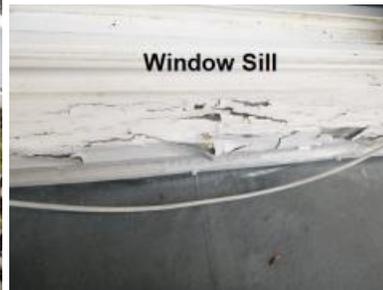
One window Sill on the right elevation is deteriorated and needs to be replaced. Several other window sills need to be painted to prevent further damage.

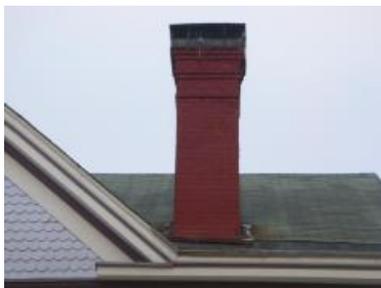
Minor Peeling of paint was noted on the chimney.

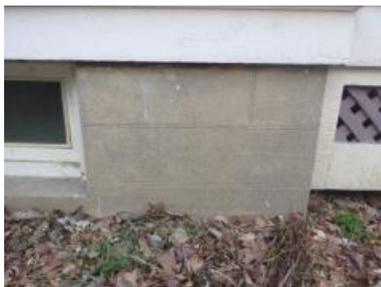
The foundation is poured concrete over 100 years in age. Considering the age of the foundation, its condition is remarkably good.

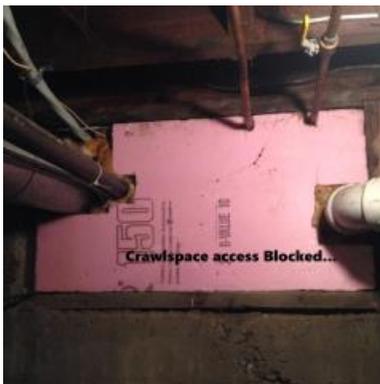
The access to the crawlspace was restricted which prohibited entering at the time of the inspection.

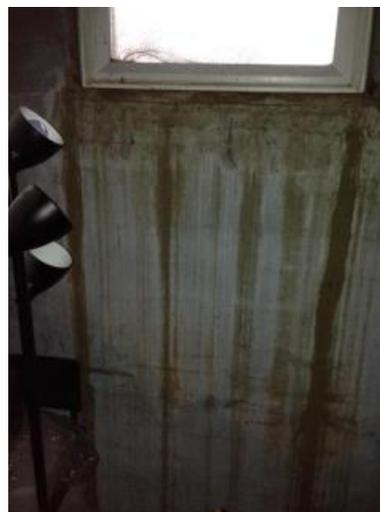
No moisture was noted on the day of inspection. There was evidence of past water seepage below one of the windows, though the amount of water seeping through seemed to be small and intermittent.

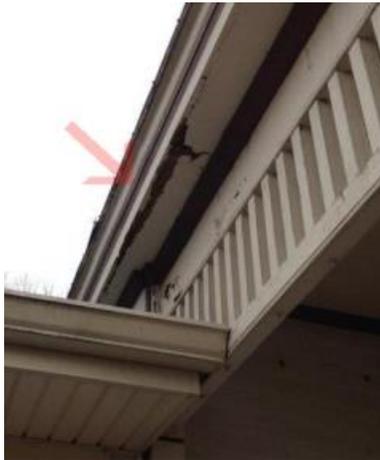
Wood soffits under the rear porch are water damaged. Repairs may be needed to the box gutters.

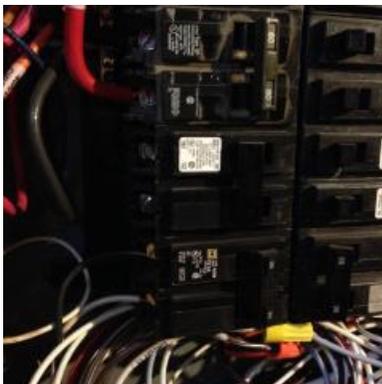
<i>Main Circuit Rating:</i>	100 amps.
<i>Entrance Cable Size:</i>	2/0 Aluminum.
<i>Main Panel Observations:</i>	Breaker off - However, no conductors were attached to the breaker.

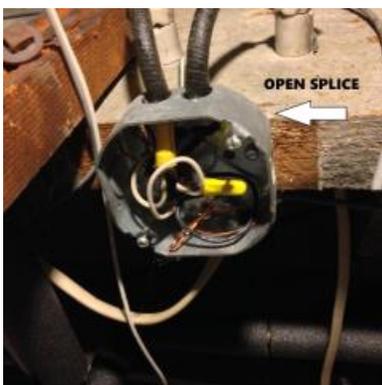
Open junction boxes are noted.

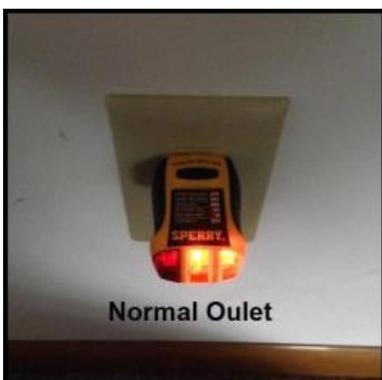
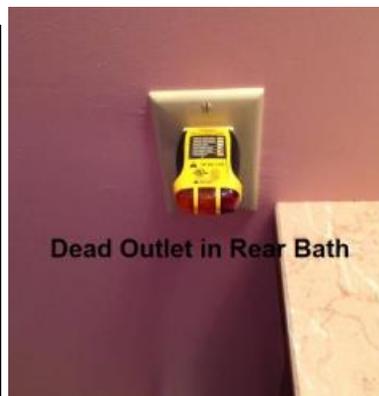
The GFI in the rear bathroom was not receiving power. Recommend that a qualified electrician make repairs as necessary.

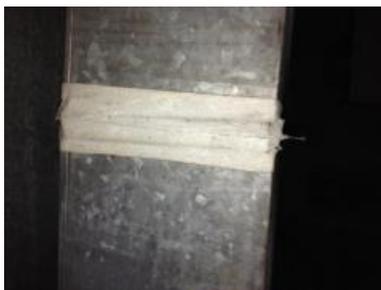
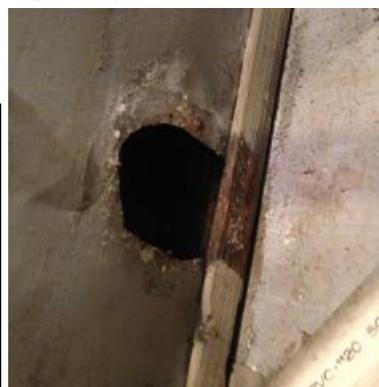
There were several holes and leaks in the supply and return ducts that will negatively effect supply and return air in the HVAC system. The white tape around several of the duct joints in the basement appears to be asbestos. Disturbing these joints should be avoided.

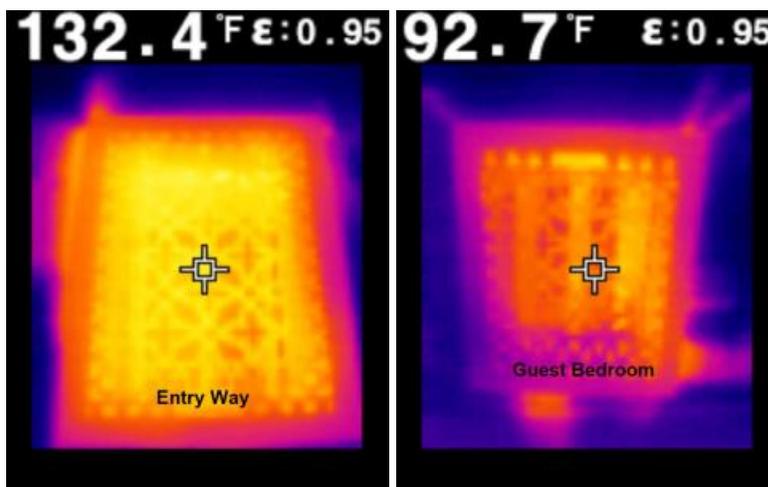
Air delivered on the first floor was as much as 40 degrees warmer than air delivered upstairs. This may cause a lack of comfortable heating and air conditioning in weather extremes.

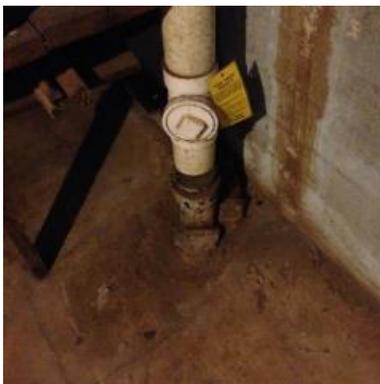
Evidence of a minor prior leak was noted at the main line in the basement. Line did not leak while on site.

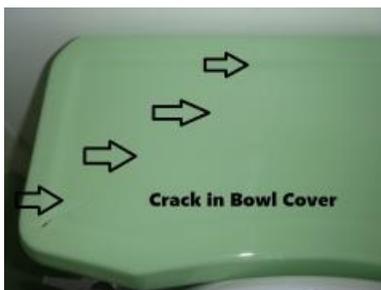
Master Bath:	<input type="checkbox"/>	<input checked="" type="checkbox"/>	<input type="checkbox"/>	The upstairs bathroom cabinet cover was broken and appeared to be glued back together. This should be replaced as it could easily break again and cause harm to persons or property. Toilet does not flush properly and needs repair.
--------------	--------------------------	-------------------------------------	--------------------------	---

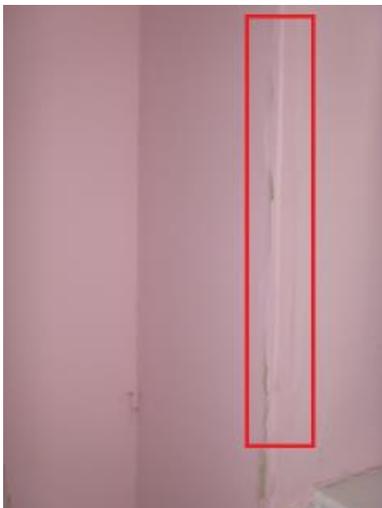
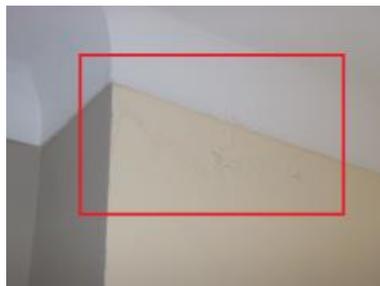
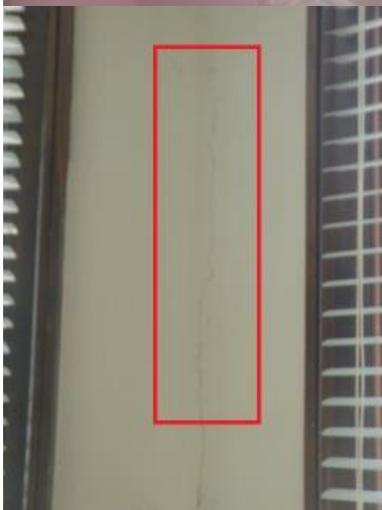
There is some minor cracking noted. Be sure to take note of any future movement. Most minor cracking is due to shrinkage of the construction materials. Some cracking may be caused by condensation in the chimney.

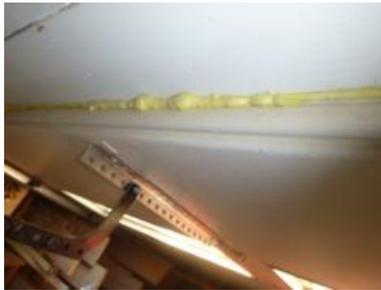
The left overhead door, looking from front to rear, and labeled "L" on the opener, was sealed shut with expanding spray foam. The door on the right functioned properly, and reversed when met with resistance.
